RE: Afternoon/Evening Ambient Air Monitoring Activity – 1/19/2026
City of Galena Construction and Demolition Landfill
KDHE Permit No. 738
Galena, Cherokee County, Kansas

Ambient Air Monitoring Locations Map

City of Galena, KS C&D Landfill
DKHE Permit No. 738

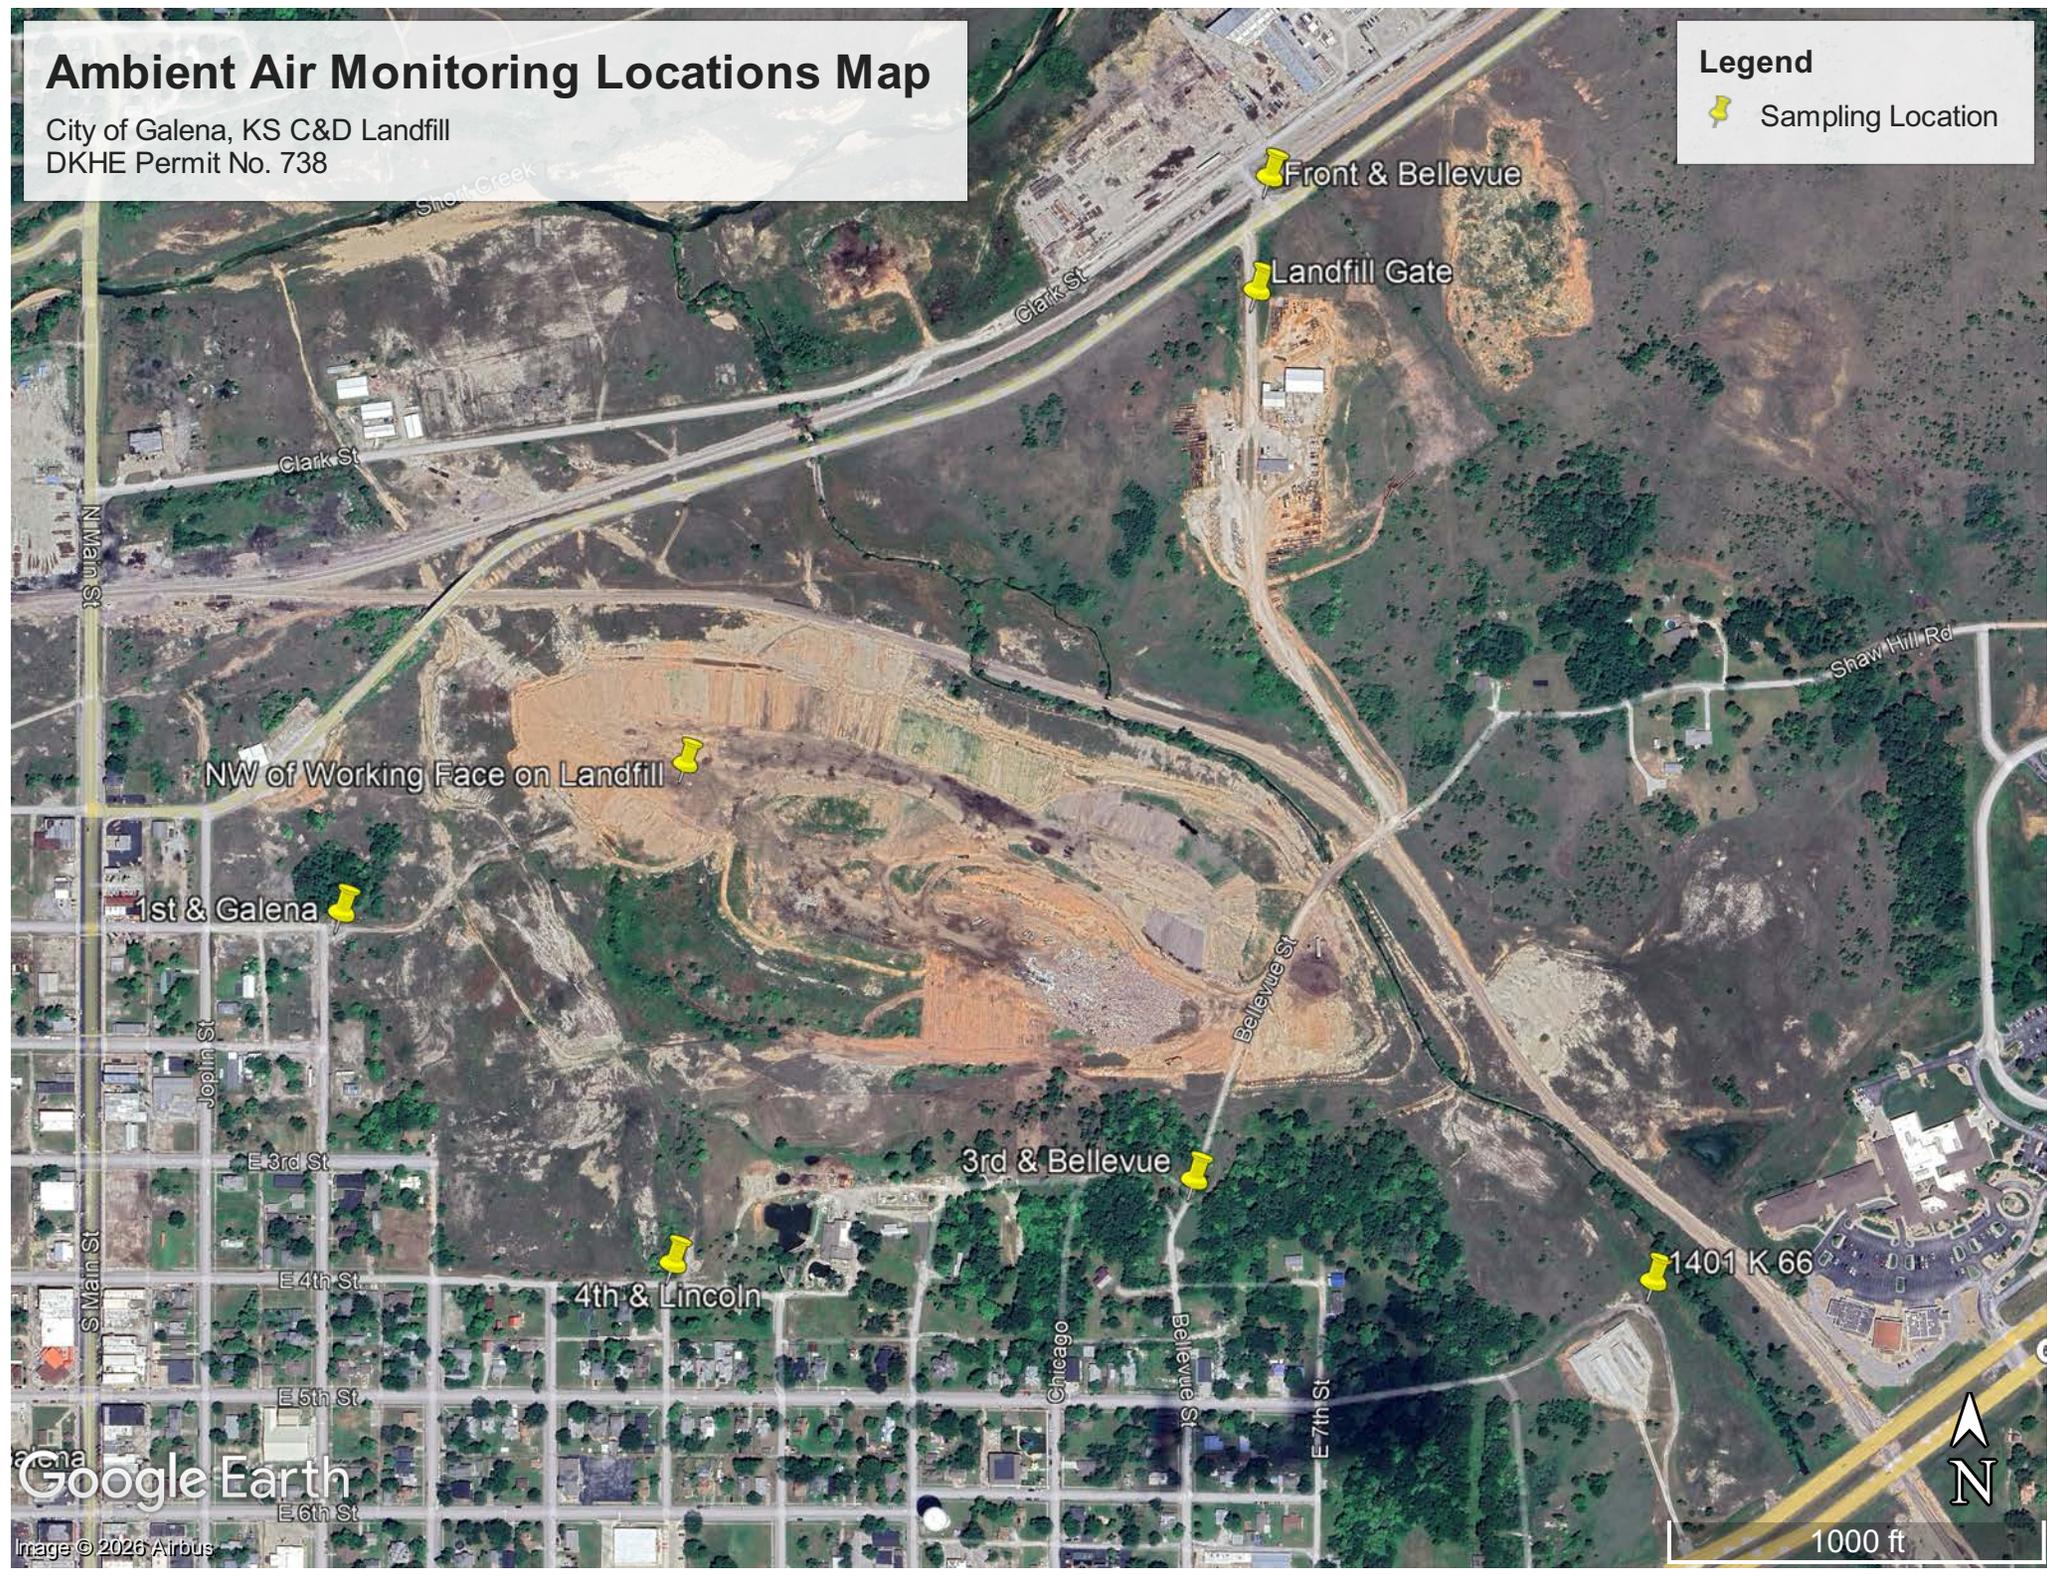
Ambient air monitoring was conducted on the afternoon and evening of January 19, 2026, for hydrogen sulfide (H₂S) around the Jordan Disposal Landfill. The afternoon event was after discovering a “warm spot” on the NW side of the landfill during a thermal inspection alongside Michelle Murphy. A significant odor was observed at that location around 1:30pm, and the Jerome unit was subsequently obtained and used to analyze three air samples approximately 2 to 3 feet above the ground at that location. Per manufacturer recommendations, the Jerome J605 unit was regenerated and fresh air “zeroed” using the appropriate zero air filter prior to sampling the ambient air for H₂S concentrations. The standard seven (7) predetermined locations were analyzed later in the evening, per the typical protocol. Basic weather information was collected at each location at the time of sampling from the Apple Weather Application and documented along with the H₂S reading from the J605 unit. The sampling locations are exhibited in Figure 1 attached to this summary letter, and the collected data is presented in Table 1 below.

NW of Working Face on Landfill

Front & Bellevue

Landfill Gate

1st & Galena

3rd & Bellevue

4th & Lincoln
