RE: Morning Ambient Air Monitoring Activity – 5/12/2026
City of Galena Construction and Demolition Landfill
KDHE Permit No. 738
Galena, Cherokee County, Kansas

Ambient Air Monitoring Locations Map

City of Galena, KS C&D Landfill
KDHE Permit No. 738

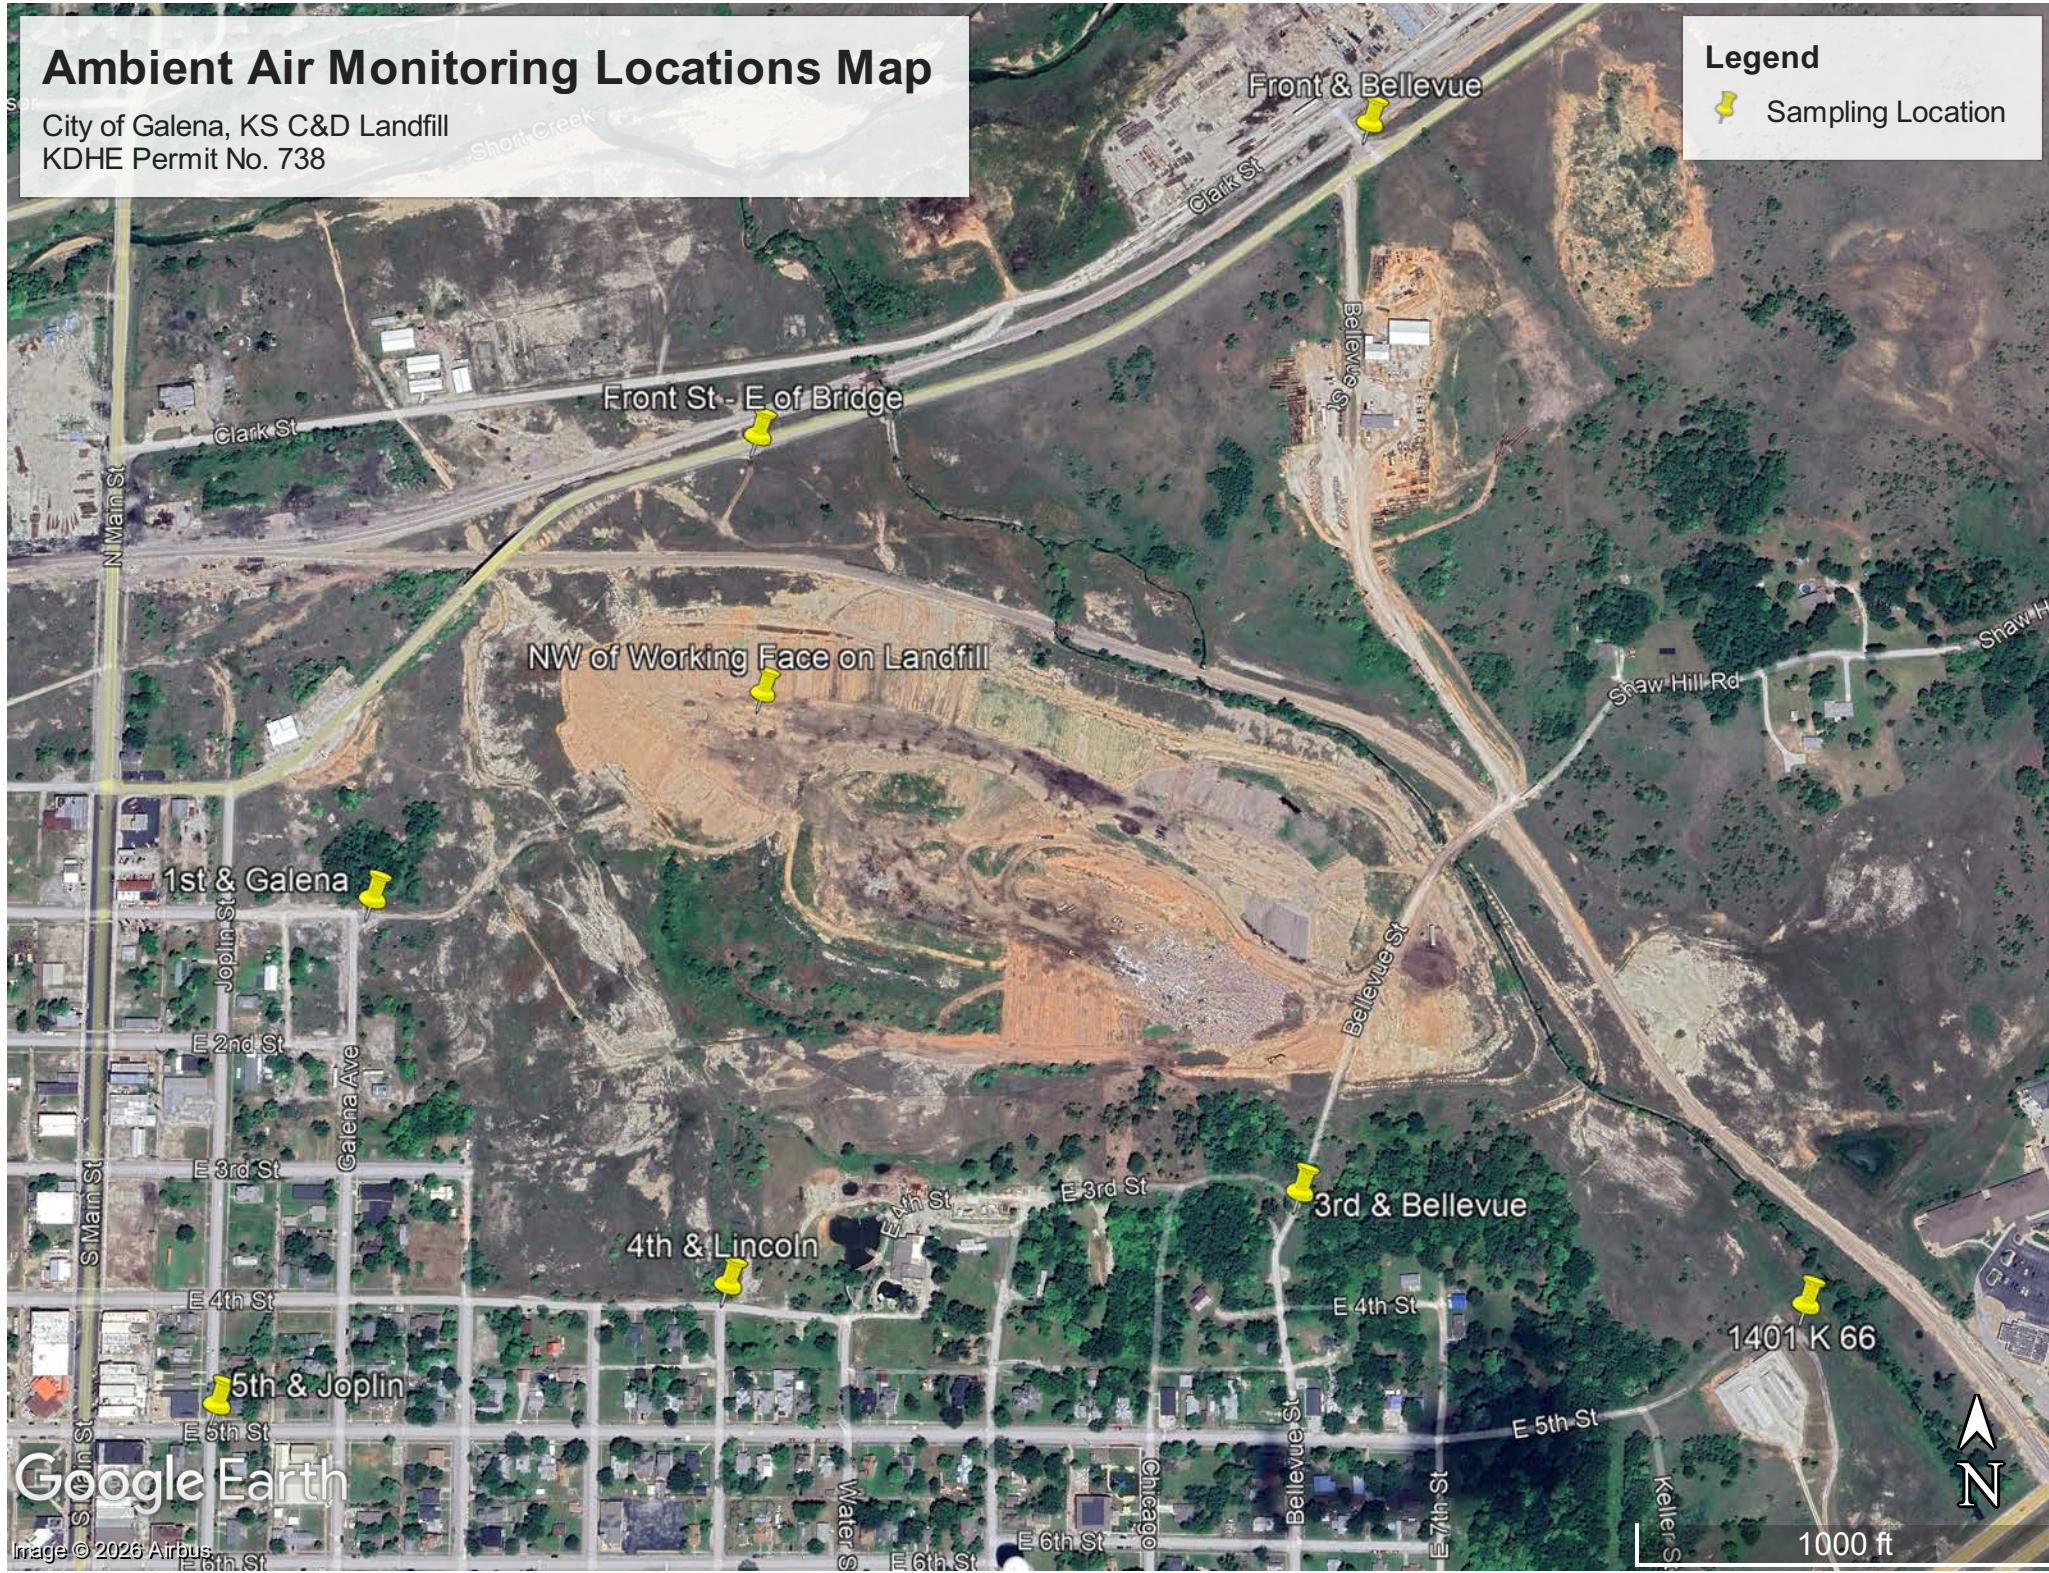
Ambient air monitoring was conducted on the morning of May 12, 2026, for hydrogen sulfide (H₂S) around the Jordan Disposal Landfill. Per manufacturer recommendations, the Jerome J605 unit was regenerated and fresh air “zeroed” using the appropriate zero air filter prior to sampling the ambient air for H₂S concentrations at eight (8) predetermined locations. Basic weather information was collected at each location at the time of sampling from the Apple Weather Application and documented along with the H₂S reading from the J605 unit. The sampling locations are exhibited in Figure 1 attached to this summary letter, and the collected data is presented in Table 1 below.
