**RE: Evening Ambient Air Monitoring Activity – 7/10/2026**  
City of Galena Construction and Demolition Landfill  
KDHE Permit No. 738  
Galena, Cherokee County, Kansas

# Ambient Air Monitoring Locations Map

City of Galena, KS C&D Landfill  
KDHE Permit No. 738

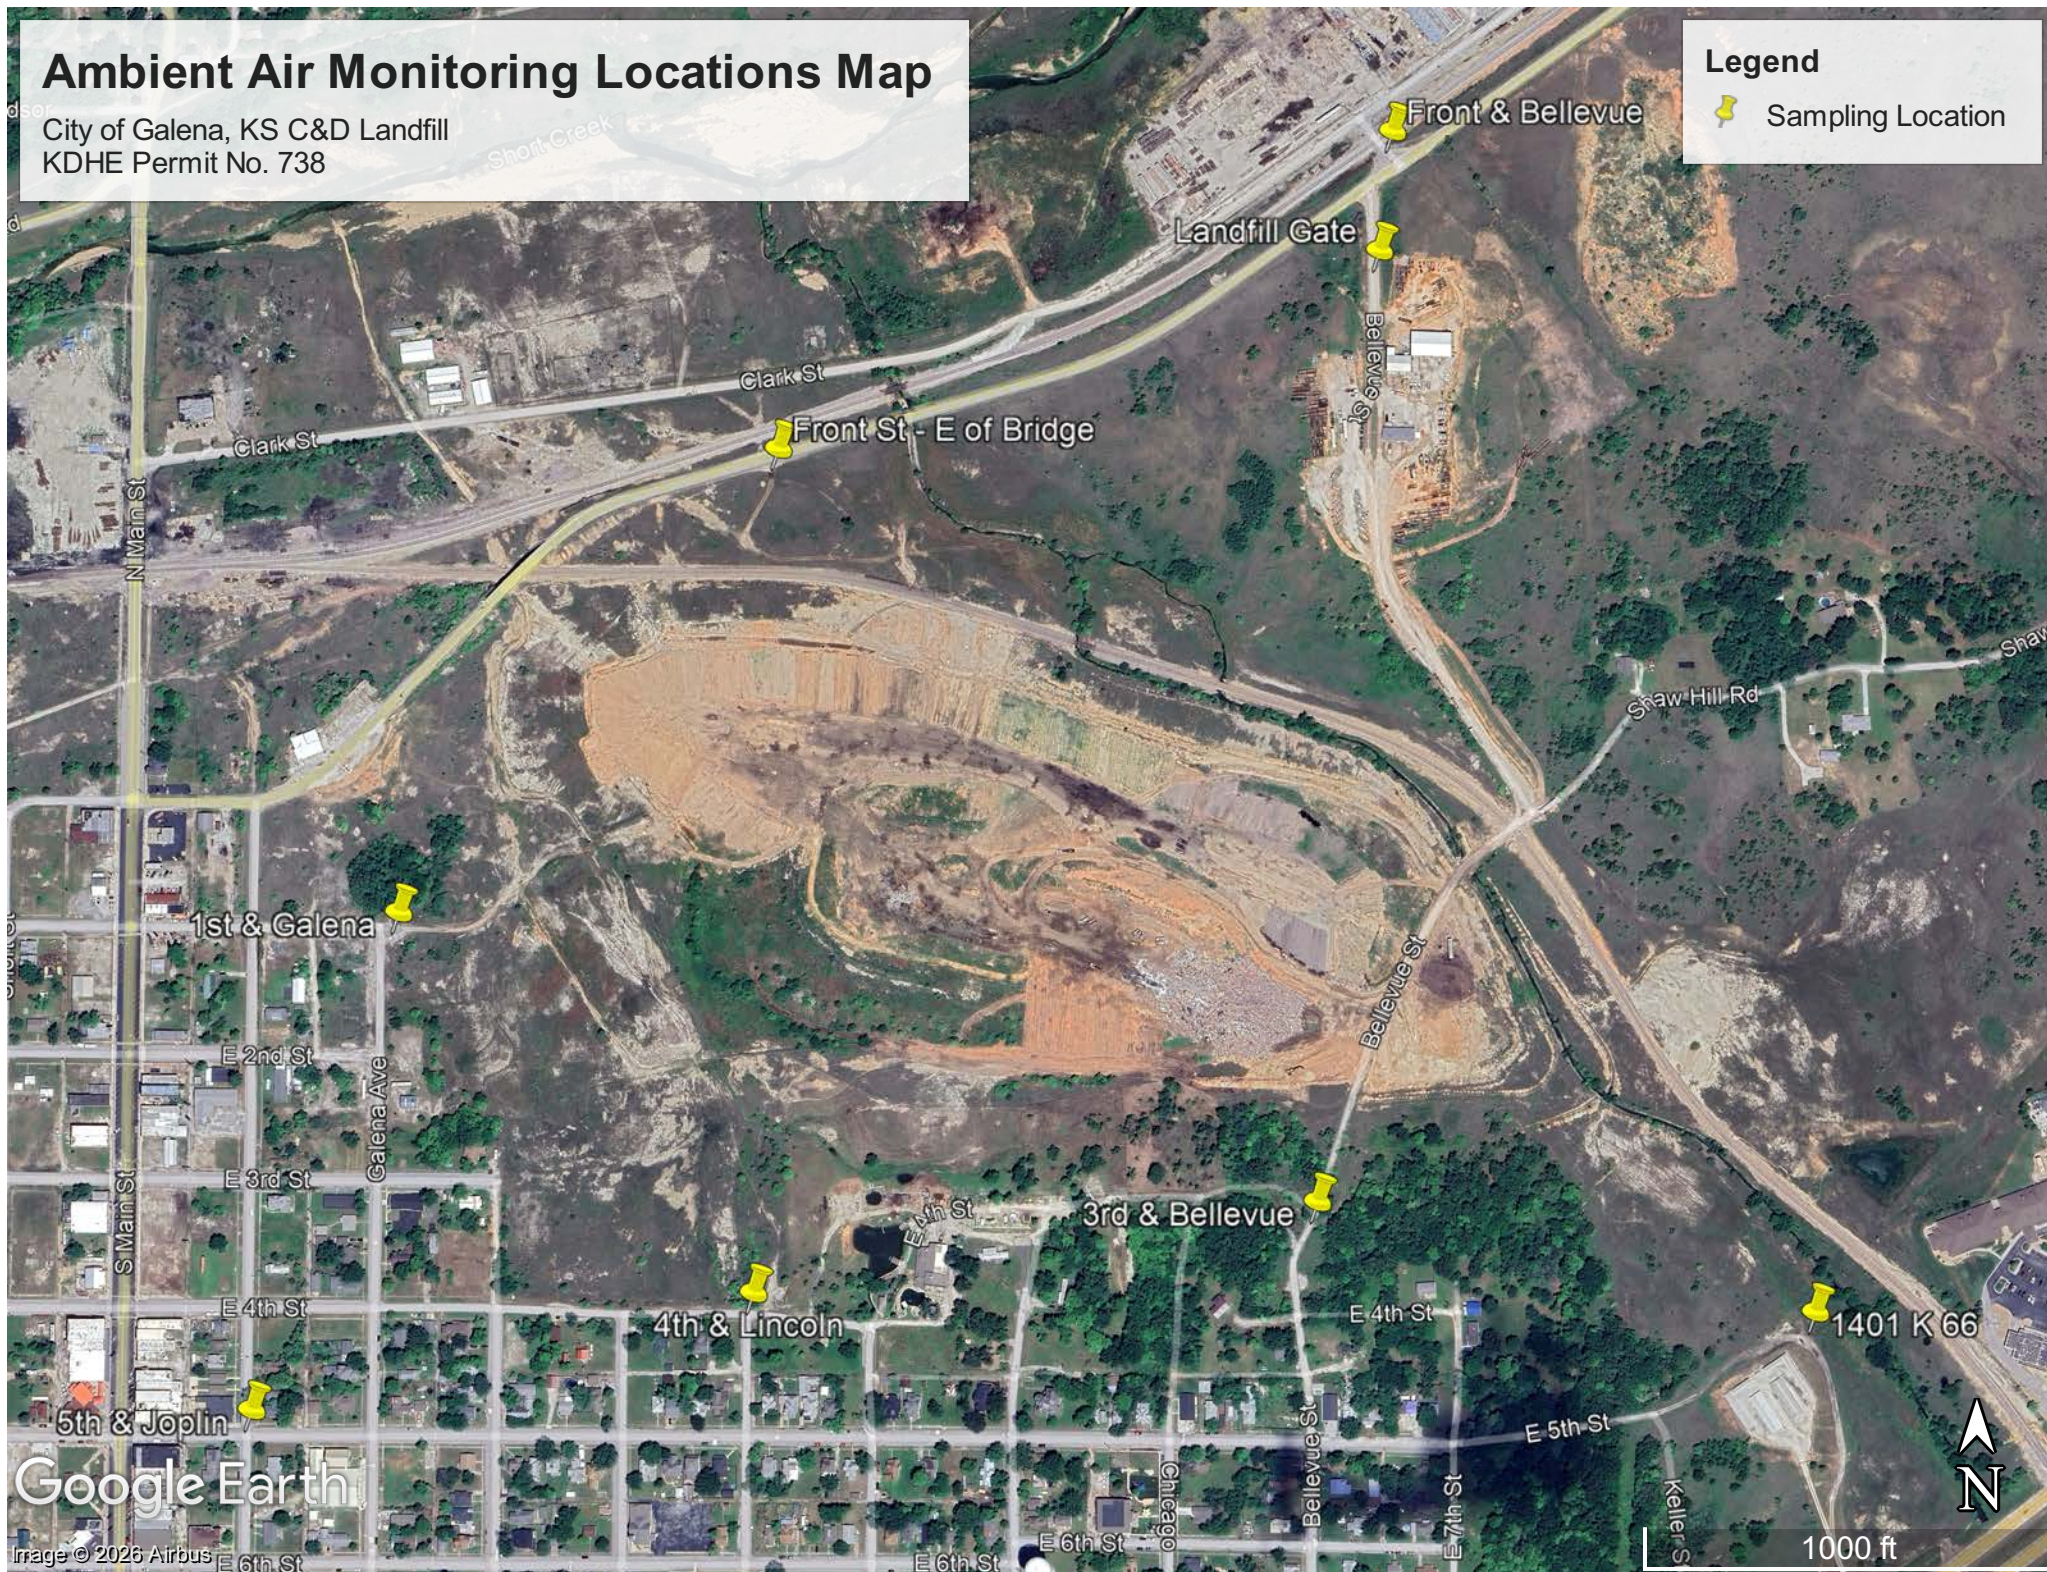
Ambient air monitoring was conducted on the evening of July 10, 2026, for hydrogen sulfide (H<sub>2</sub>S) around the Jordan Disposal Landfill. Per manufacturer recommendations, the Jerome J605 unit was regenerated and fresh air “zeroed” using the appropriate zero air filter prior to sampling the ambient air for H<sub>2</sub>S concentrations at eight (8) predetermined locations. Basic weather information was collected at each location at the time of sampling from the Apple Weather Application and documented along with the H<sub>2</sub>S reading from the J605 unit. The sampling locations are exhibited in Figure 1 attached to this summary letter, and the collected data is presented in Table 1 below.
